## Arresting the Moving Slopes of Andamans – A Case Study 2.51L

## ARRESTING THE MOVING SLOPES OF ANDAMANS

Paper No 2.51L

**Colonel (Dr) Shri Pal**  
Commander Works Engineers.  
Calcutta - 700 027, INDIA

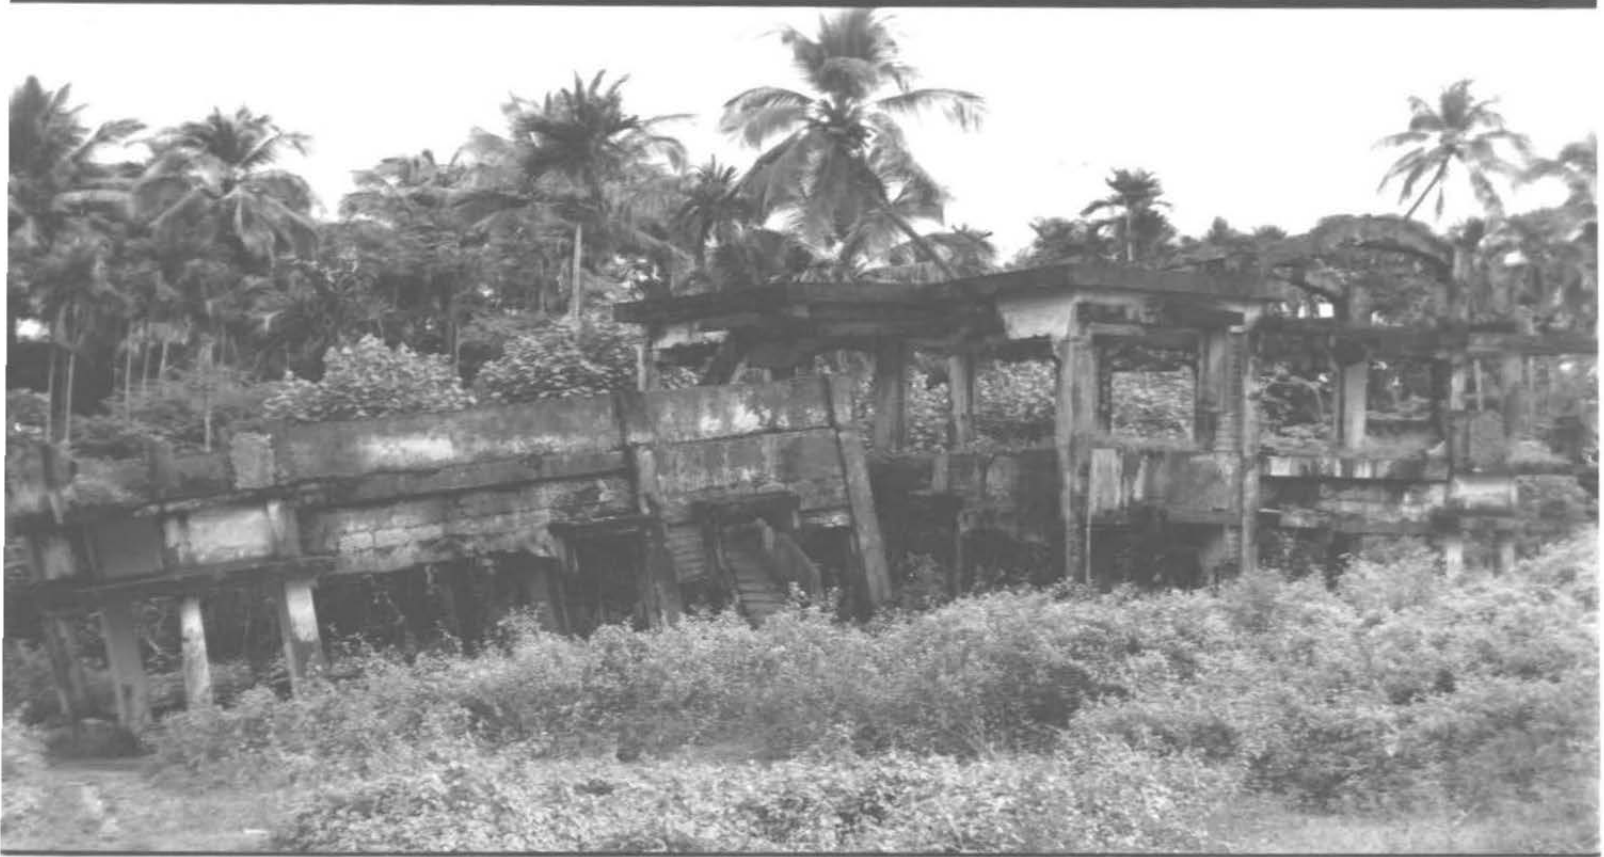
Other signs of distress and slope movement in this area are shown by the tilted and damaged building shown in Fig 1 which had to be abandoned very soon after its construction. A land slide in the same area also occurred damaging the roads.

**Fig 1. Tilted and Damaged Building due to Subsidence and Mass Movement**

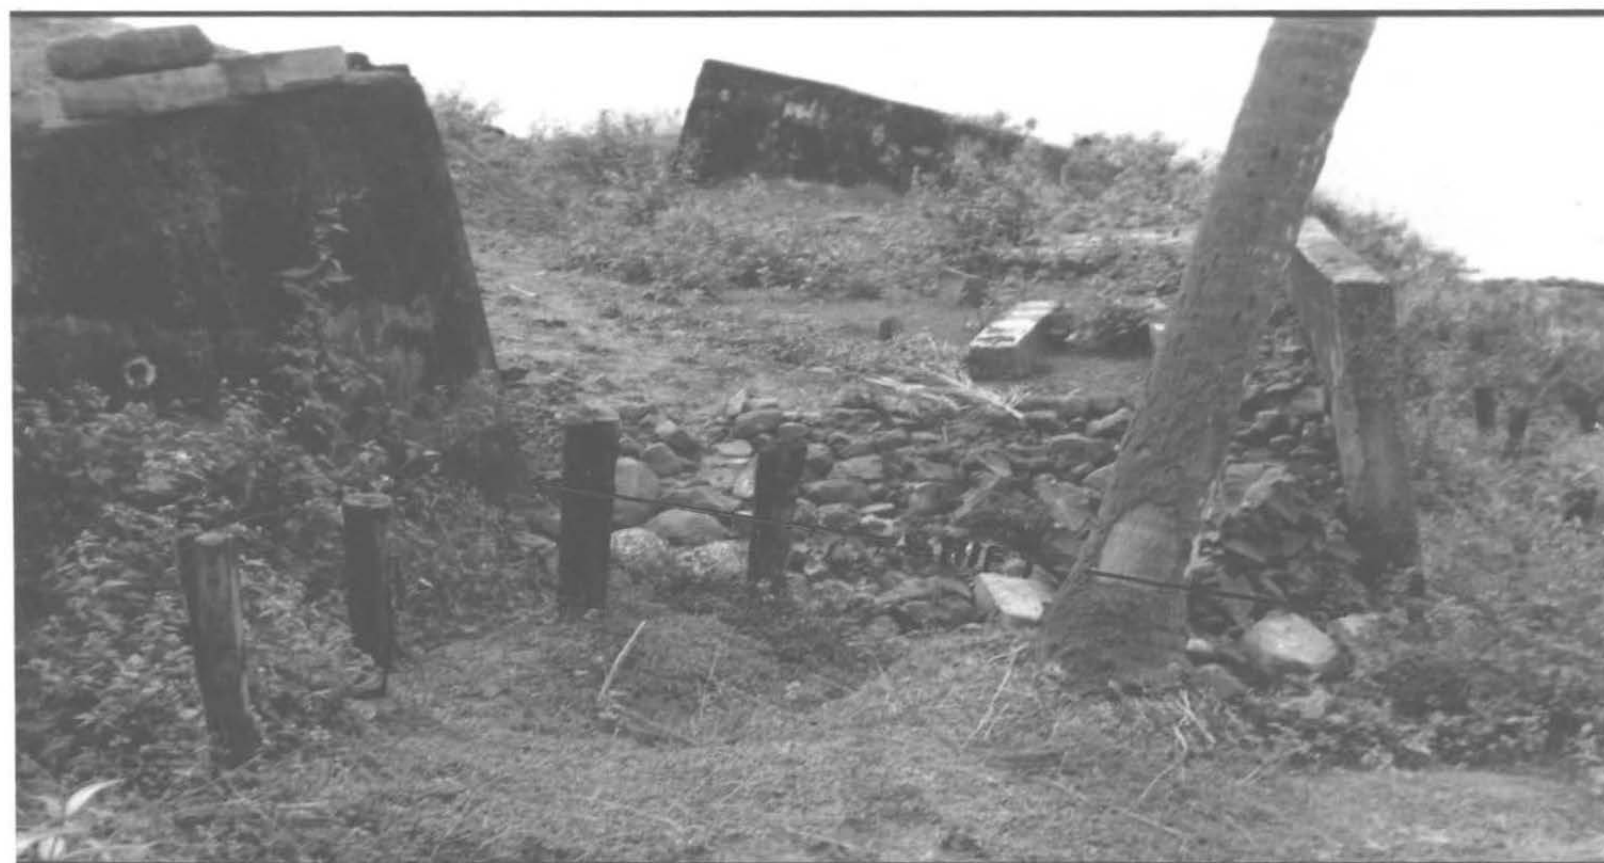
**Fig 2 Shifting of retaining Wall and Tilting of Tree due to Movement of Soil Mass**

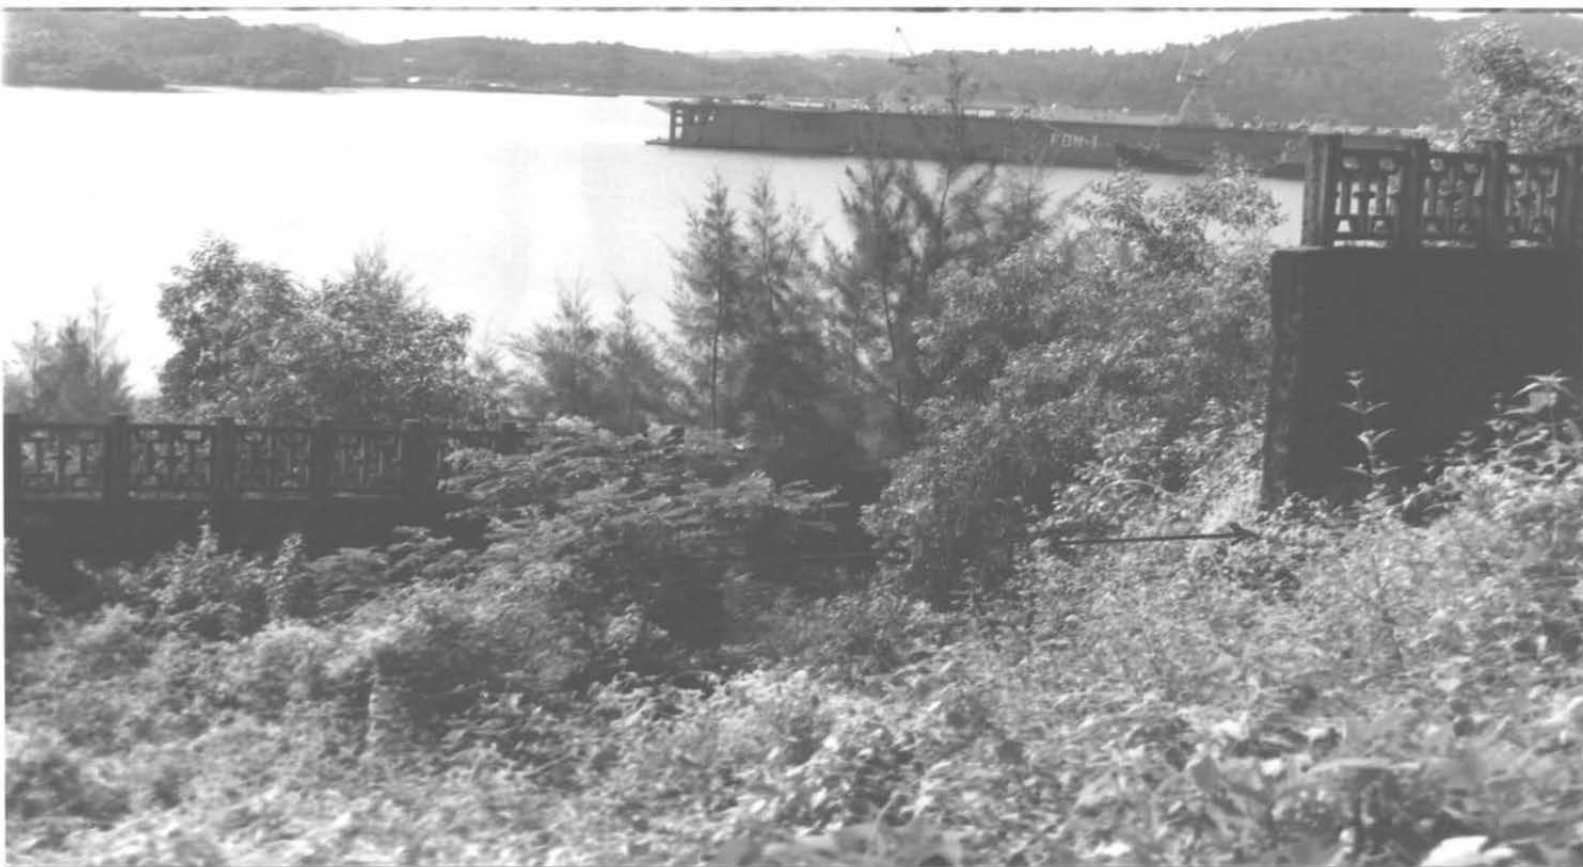
As the construction activities progressed in the area, subsidence of hill slopes in some places were noticed. A portion of the retaining wall in Naval Officers Mess Area moved by about 4 to 7 cm in 1984 during rains. In next monsoon the wall moved more than 90 cm despite reducing the earth fill behind it. Till date, this wall has moved more than 6 m from its original location along with the soil surrounding it (Figs 3).

**Fig 3. Movement of Another Retaining Wall Near Naval Officer's Mess**

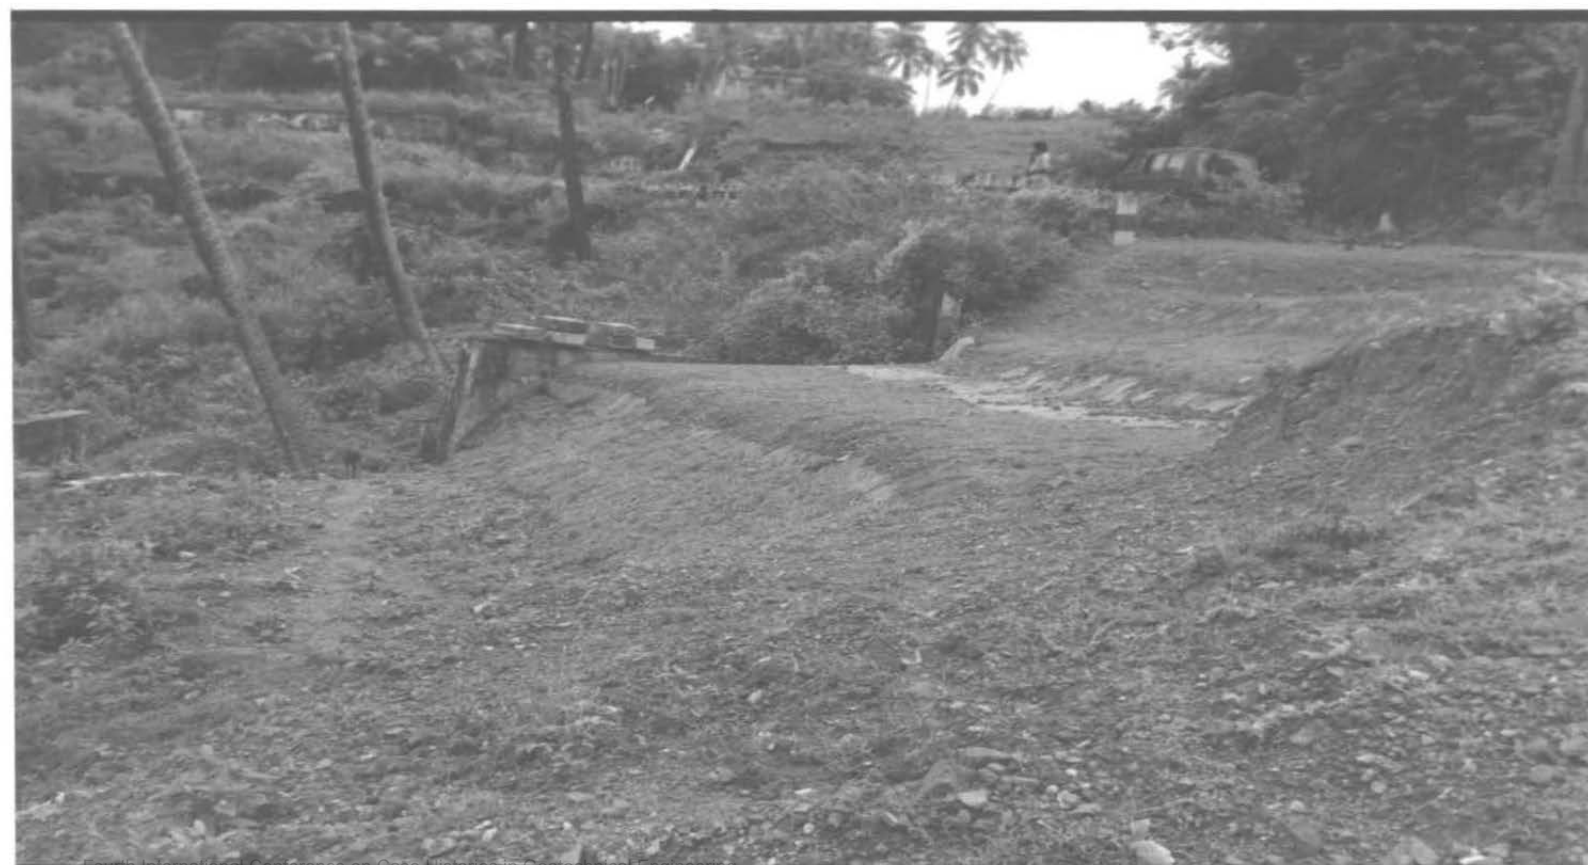
**Fig 4. Repair to Slope Near Road Embankment By Jute Based Geotextile**

Geosynthetic materials can be advantageously used in the area both in improving the horizontal and vertical sub soil drainage as well as by reinforcing the soil with concept like reinforced soil wall. The jute based geotextile and other geomats and geogrids may be gainfully utilised for promotion of growth of vegetation on natural and man made slopes in the area. A method of stabilisation of slopes by use of jute based geotextile has been used in the area for stabilisation of road side slope as shown in Fig 4.

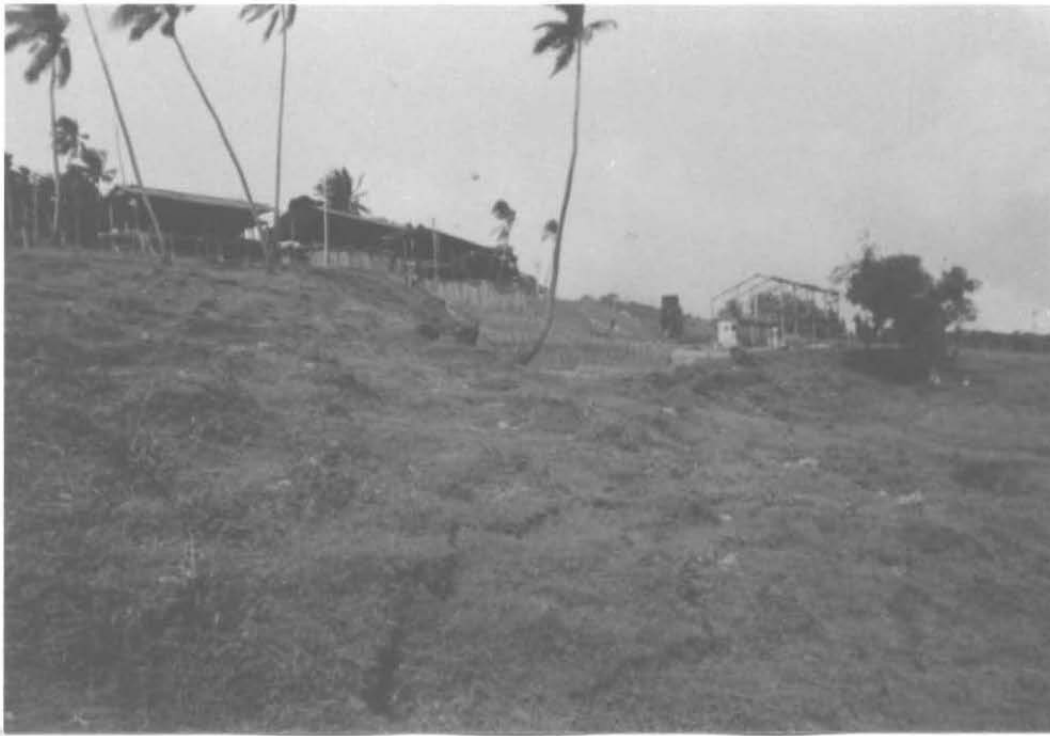
**Fig. 5 Repair to Slope by Bamboo Piling and Stone Crates in Buniyadabad Area in 1994.**

Based on the above conclusion it is revealed that improvement of subsoil drainage to keep the water table at least 1 m below the surface and improving the cohesion of the soil are two important factors in stabilisation of slopes in this area. The details of repair to a hill slope carried out in 1994 where road was damaged due to land slide in Buniyadabad Area is shown in Fig 5. The successive stone crate protection with bamboo piling in the soil were aimed at achieving better cohesion and subsoil drainage in the area. This type of repair work has been observed quite satisfactory over last two years. The slope has stabilised and sufficient greenery and
